## WHAT HAPPENS TO STRUCTURES WHEN THE GROUND MOVES?

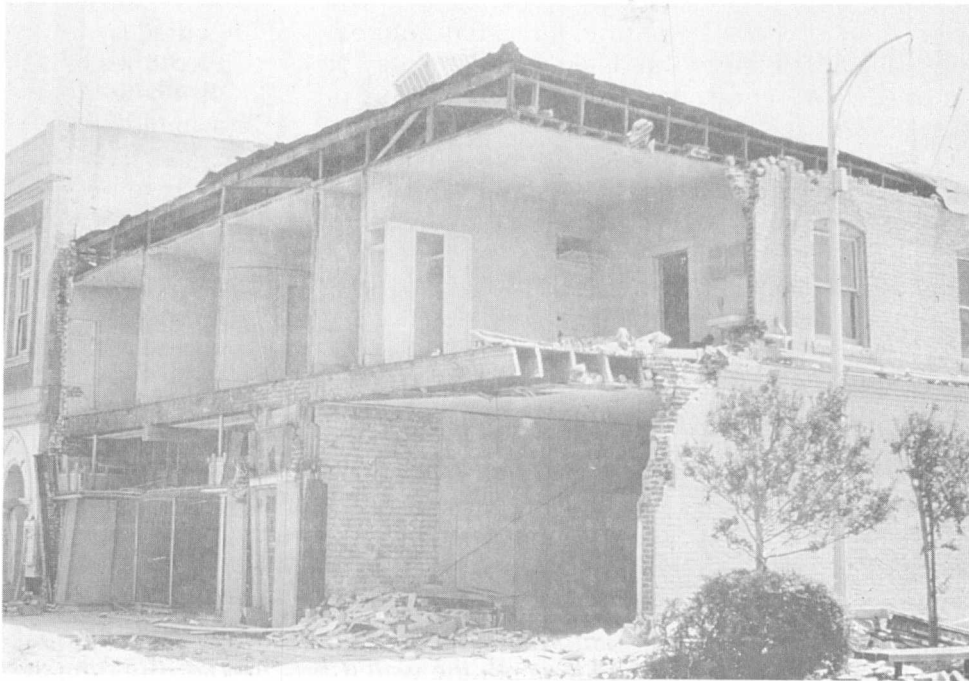
*Typical damage to unreinforced masonry buildings on the main street of Coalinga, California, after the 1983 earthquake (Chris Arnold, Building Systems Development, Inc.).*

Unreinforced masonry buildings have long been identified as performing very poorly in earthquakes. Unreinforced masonry buildings typically have brick or block bearing walls and wood-framed floors and roofs. The floors and roofs tend to pull away from the walls and collapse; the upper portions of walls, particularly parapets, tend to fall and, depending on the quality and age of the mortar, walls tend to disintegrate.

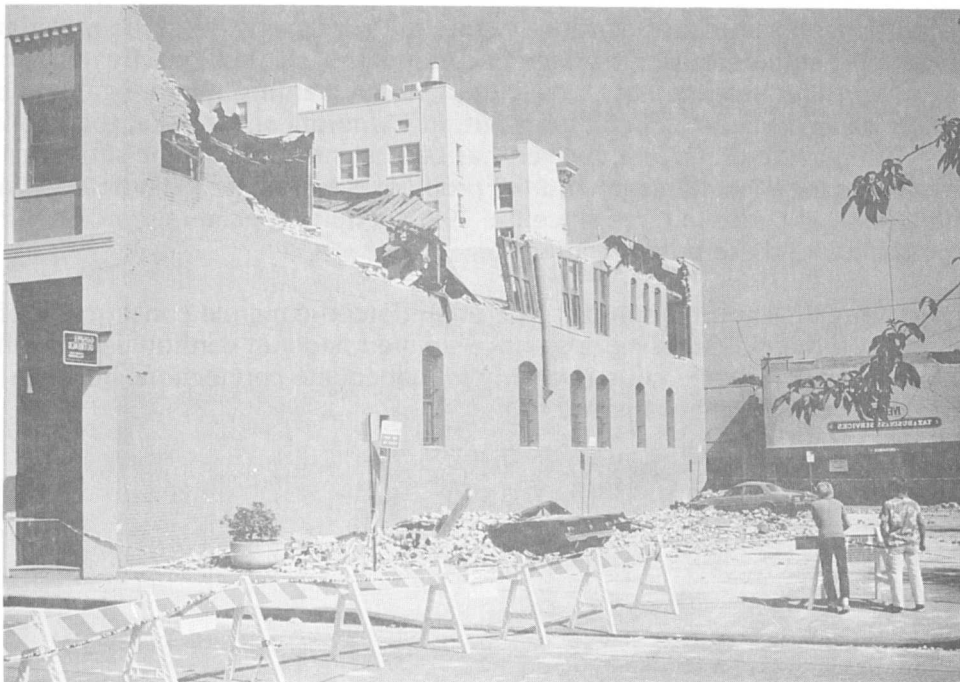
*Typical upper wall failures after the 1987 earthquake in Whittier, California (Chris Arnold, Building Systems Development, Inc.).*

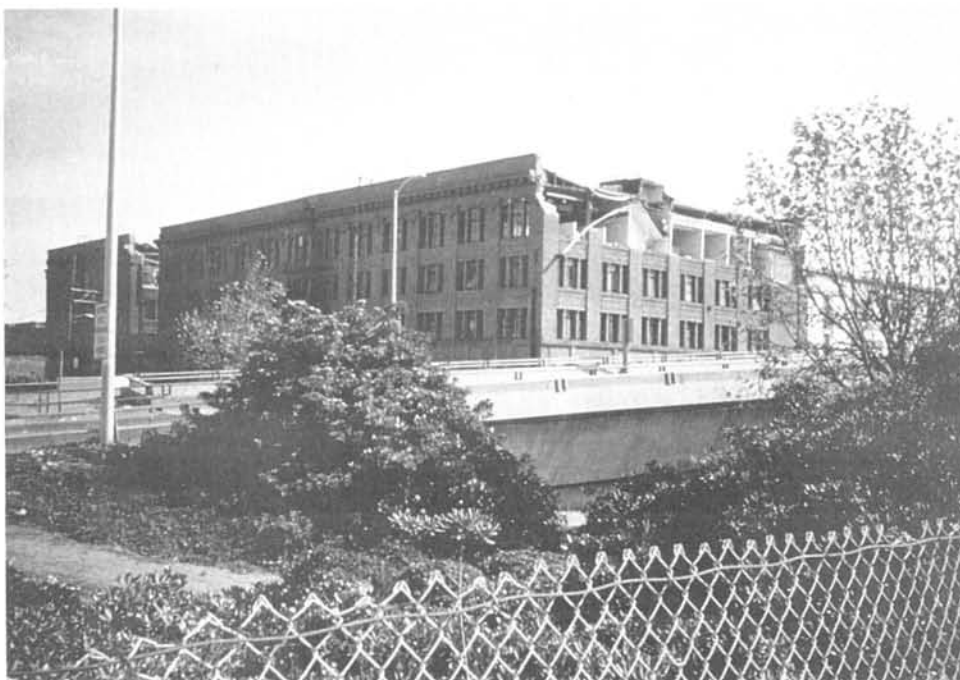
*Upper wall failure in San Francisco, California, after the 1989 Loma Prieta earthquake; this collapse killed six people in cars parked beneath the wall (Chris Arnold, Building Systems Development, Inc.).*

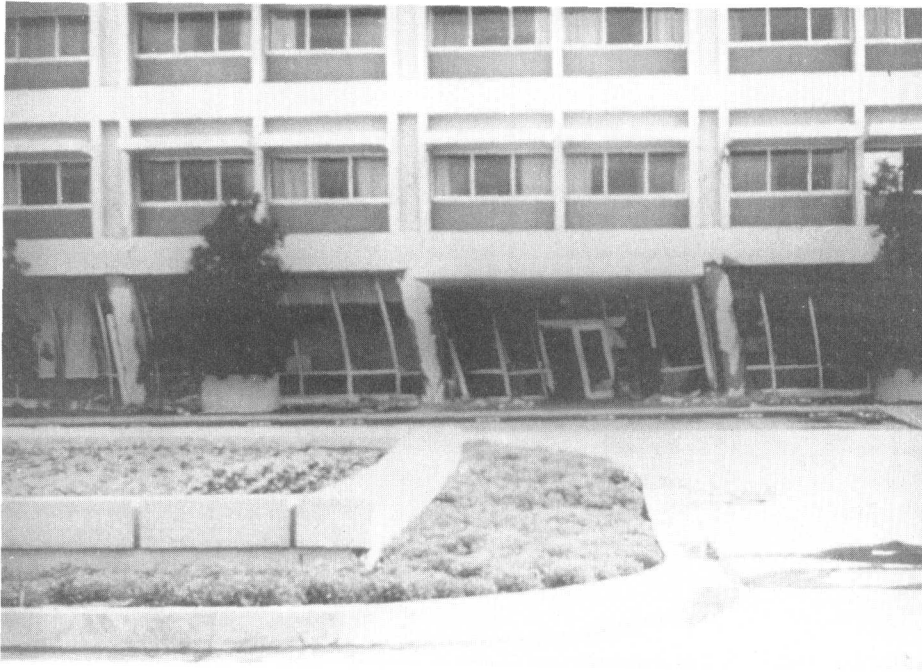
*Olive View hospital was badly damaged in the 1971 earthquake in San Fernando, California, primarily because of a "soft story" condition – that is, its lower two floors were much more flexible than the upper floors causing failure where the structure changed from flexible columns to stiff walls.*

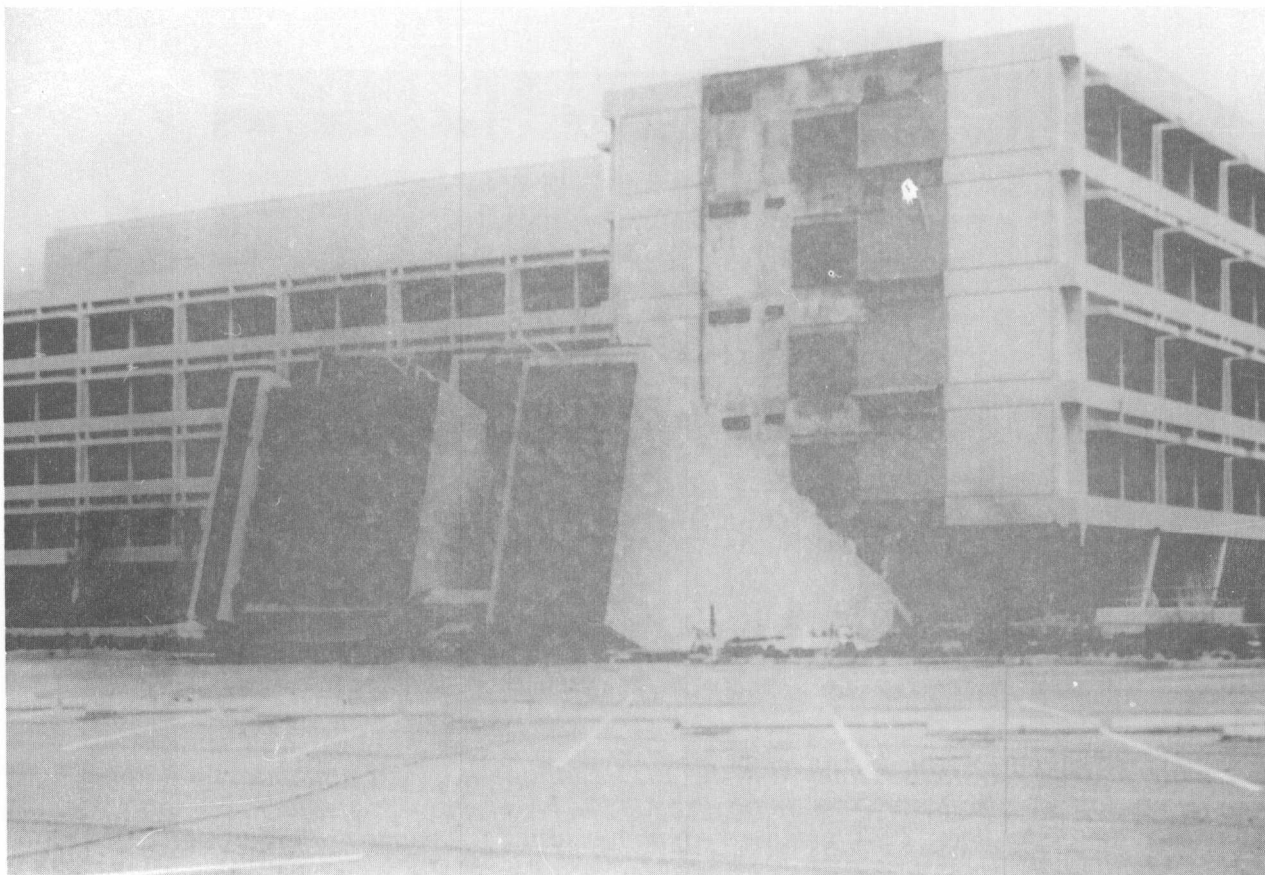
*Staircase towers at Olive View hospital collapsed, rendering evacuation of patients much more difficult; two patients were killed at this hospital because their life-support system failed, and one maintenance worker was killed by a falling canopy.*

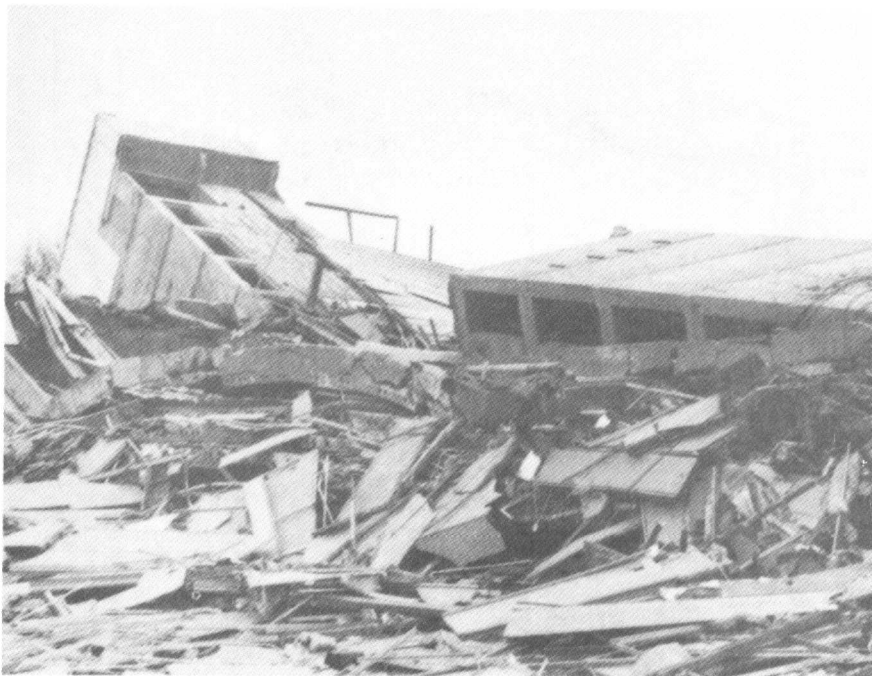
*The six-story Four Seasons apartment building in Anchorage, Alaska, before and after the 1994 earthquake. It was designed with pre-cast lift-slab floors (a form of construction no longer in use). The earthquake forces were resisted by two poured-in-place reinforced concrete towers. However, in the 1964 Anchorage earthquake, both towers proved to have inadequate strength to resist the lateral forces; they fractured at the first floor and toppled over; when the slabs tore loose from the towers, the whole building collapsed. Fortunately the building was still under construction (though structurally complete) and was unoccupied.*

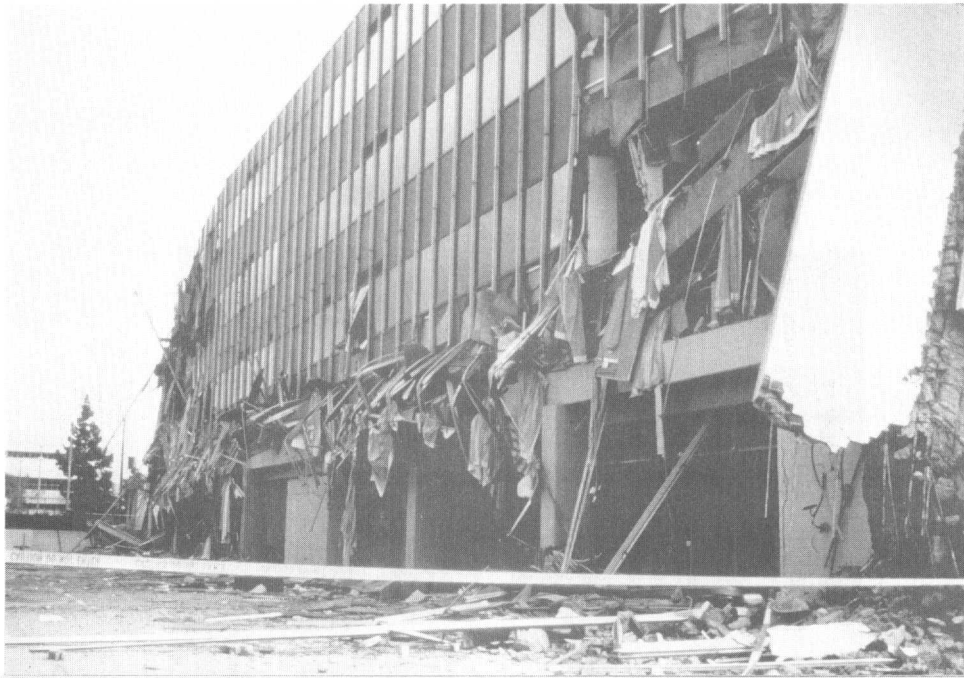
*This older medical office building suffered partial collapse at each end and the entire second floor collapsed as a result of the 1994 earthquake in Northridge, California. The building was unoccupied due to the early morning hour at which the quake occurred (Chris Arnold, Building Systems Development, Inc.).*

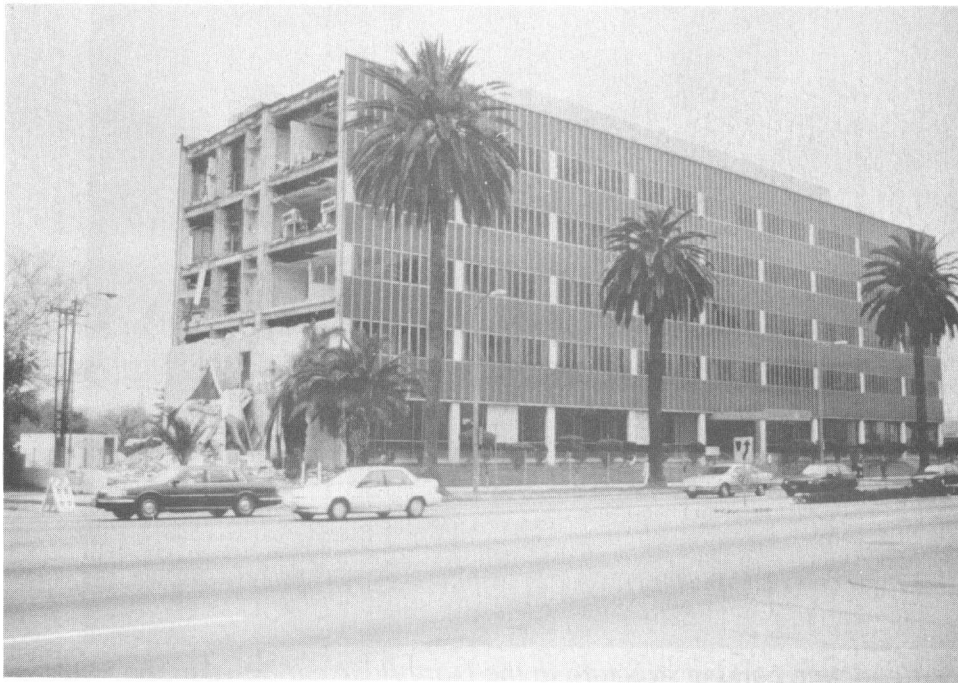
*This office building lost its end wall in the 1994 Northridge earthquake; the end wall was nonstructural and inadequately attached to the building. The comparable wall at the other end of the building was damaged but did not detach (Chris Arnold, Building Systems Development, Inc.).*

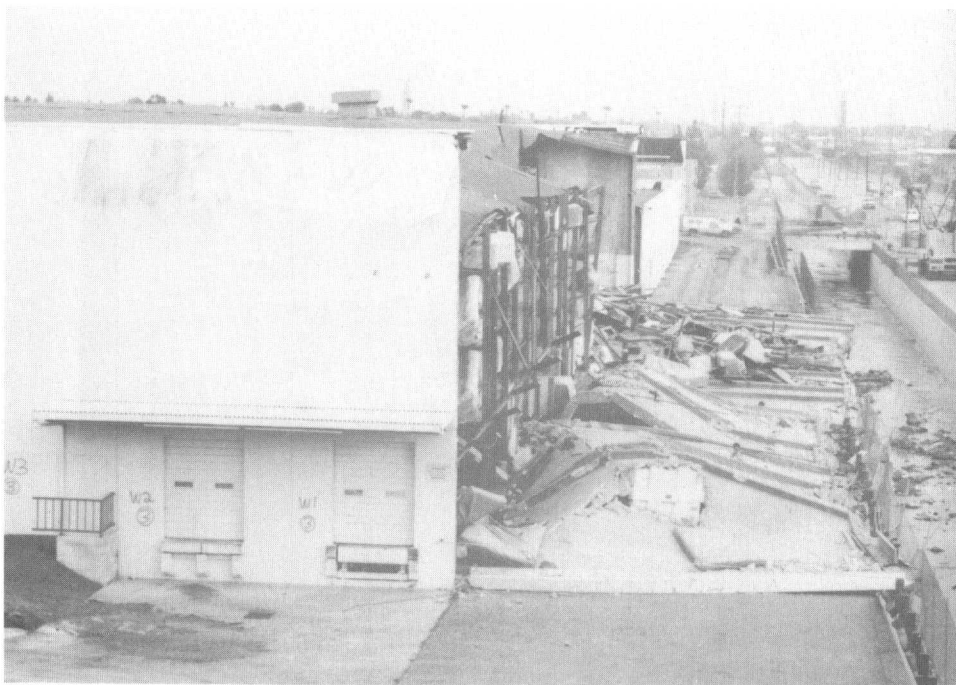
*This large commercial building, which had tilt-up concrete walls and a wood roof, lost its end wall in the 1994 Northridge earthquake. The wall was inadequately attached to the roof and movement of the heavy storage racks that now appear to support the roof may have helped to push the wall down (Chris Arnold, Building Systems Development, Inc.).*

Precast concrete structures and the "tilt-up" type of reinforced concrete construction often used for industrial and commercial buildings also have suffered badly in earthquakes. In these types of structures, the damage has been due primarily to inadequate connections between the precast members or between the walls and roof.

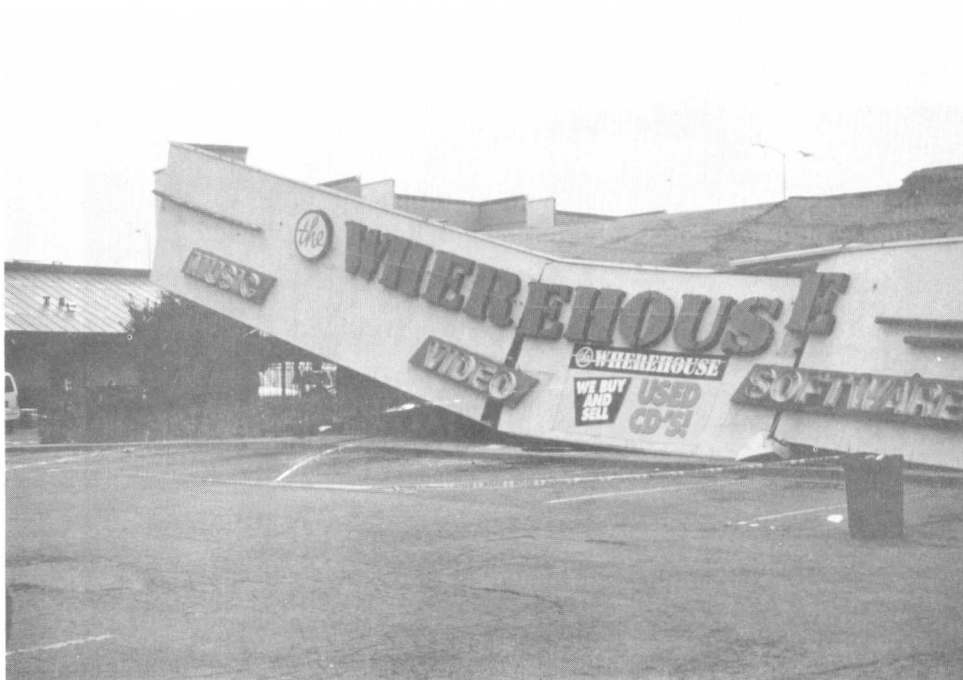
*This steel frame and reinforced masonry commercial building suffered a partial collapse in the 1994 Northridge earthquake; it had to be demolished (Chris Arnold, Building Systems Development, Inc.).*

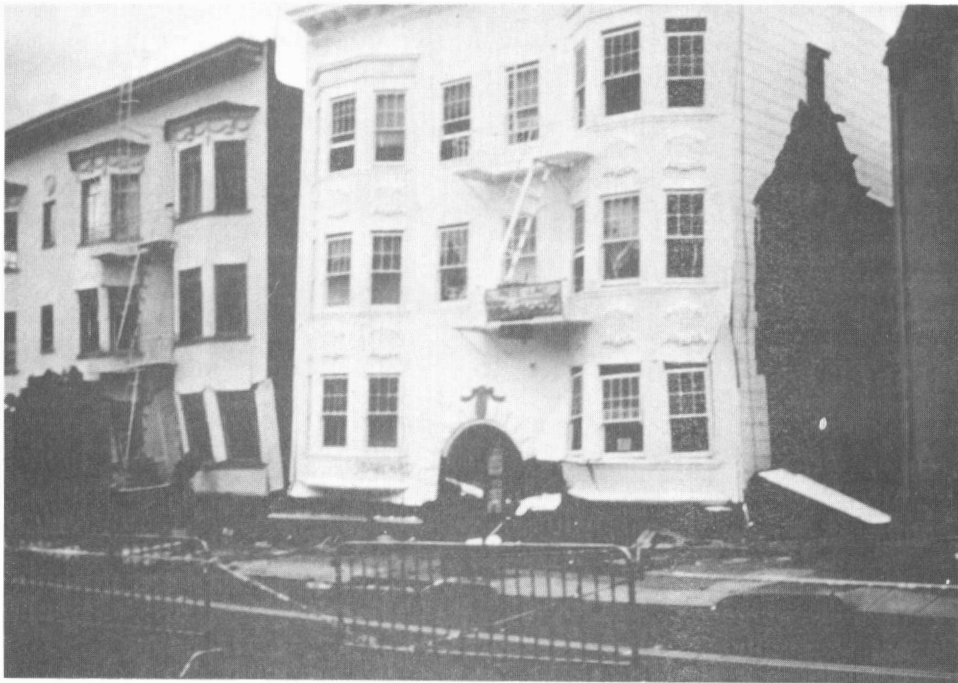
*This older San Francisco apartment house has a soft story because the garage floor is much weaker than the upper floors. It almost collapsed in the 1989 Loma Prieta earthquake (Chris Arnold, Building Systems Development, Inc.).*

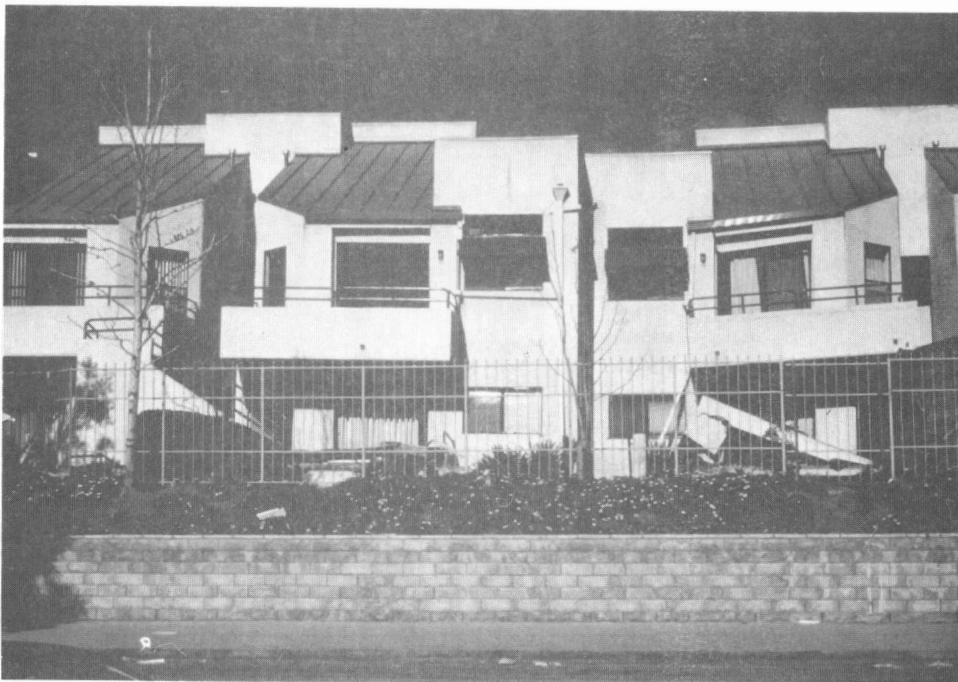
*This apartment house had a soft first story that completely disappeared during the 1994 Northridge earthquake crushing a number of parked cars. This was a fairly new building, but the earthquake found the weak points of the seismic design (Chris Arnold, Building Systems Development, Inc.).*

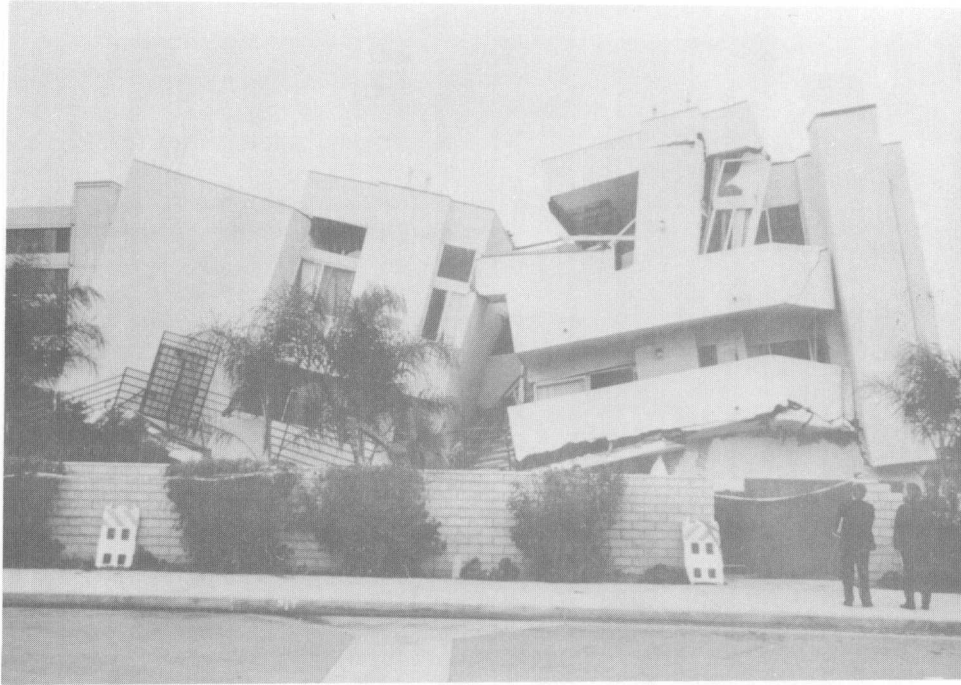
*Northridge earthquake damage to another new apartment house with a soft first story created by ground floor parking (Chris Arnold, Building Systems Development, Inc.).*

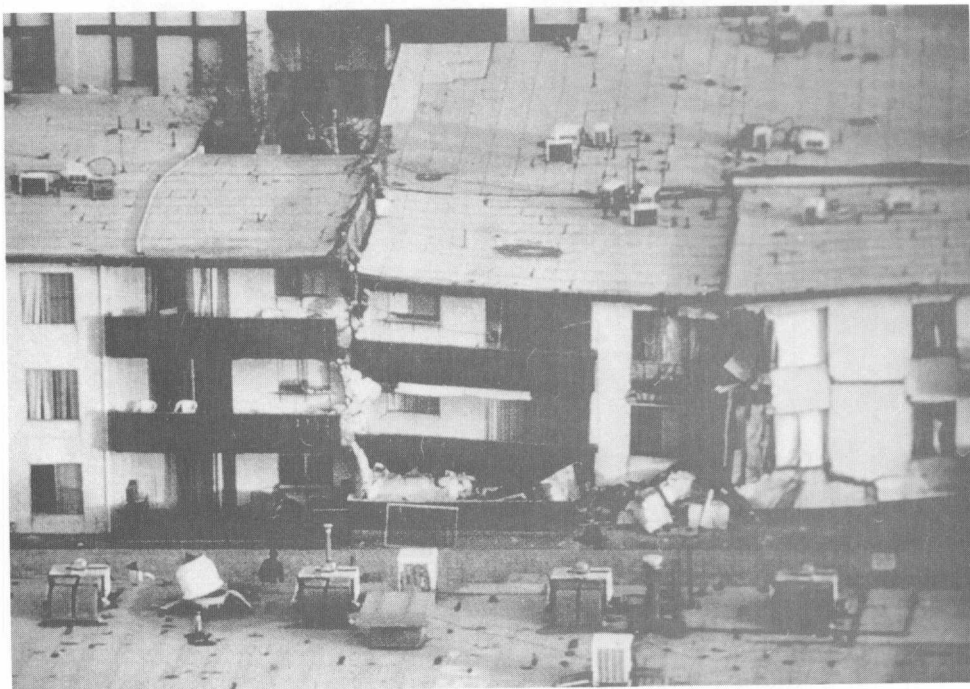
*The Northridge Meadows apartment house with a soft first story. It collapsed in the Northridge earthquake and 16 people were killed (Earthquake Engineering Research Institute).*

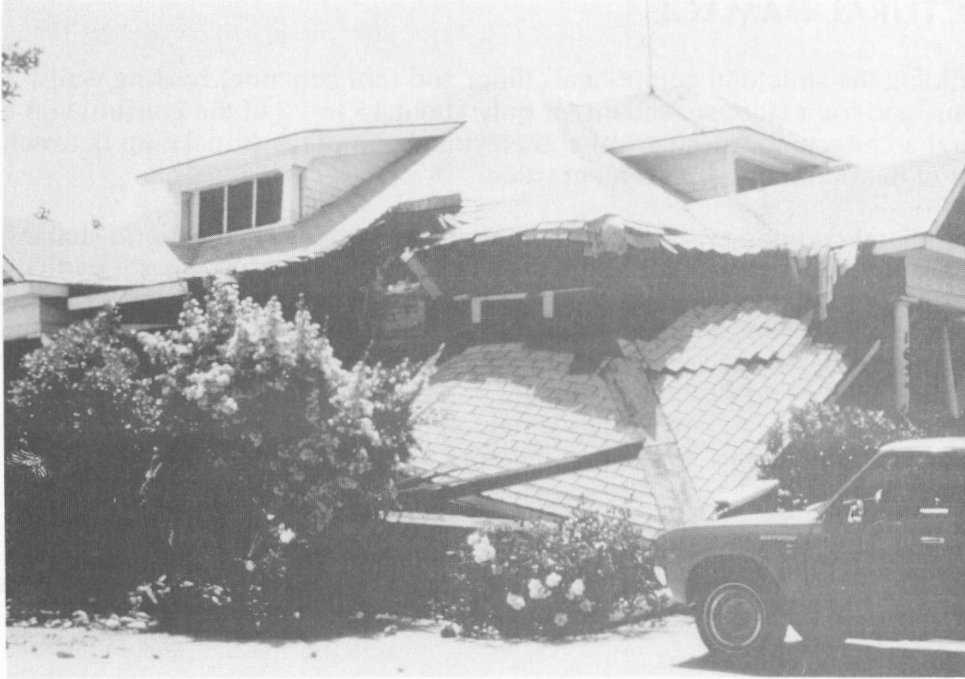
*A common example of damage to an older single-family residence as a result of the 1983 earthquake in Coalinga, California. The wood frame was too weak to support the heavy roof (Chris Arnold, Building Systems Development, Inc.).*

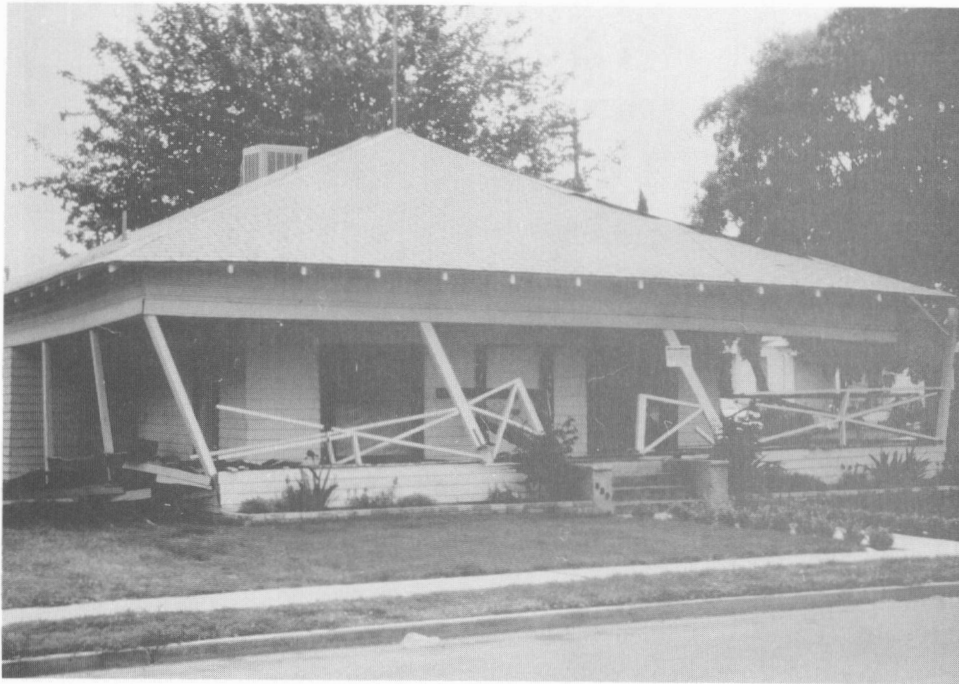
*Typical damage to a single-family residence caused by inadequate bracing of the "cripple wall" – the short stud wall between the foundation and the first floor. This type of failure causes costly damage but the problem can be solved easily by bracing the walls with plywood (Chris Arnold, Building Systems Development, Inc.).*

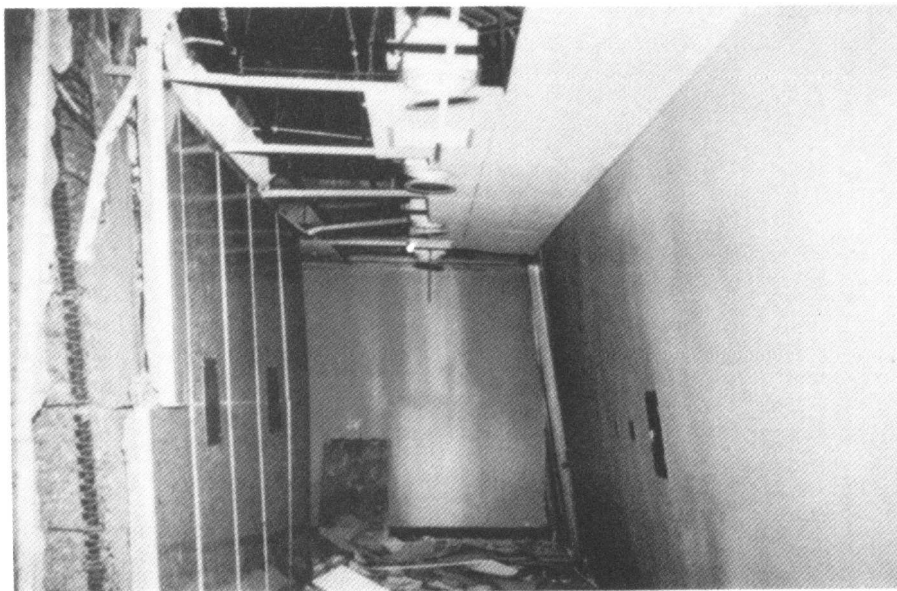
*Exit corridor in Olive View Hospital after the 1971 San Fernando earthquake.*

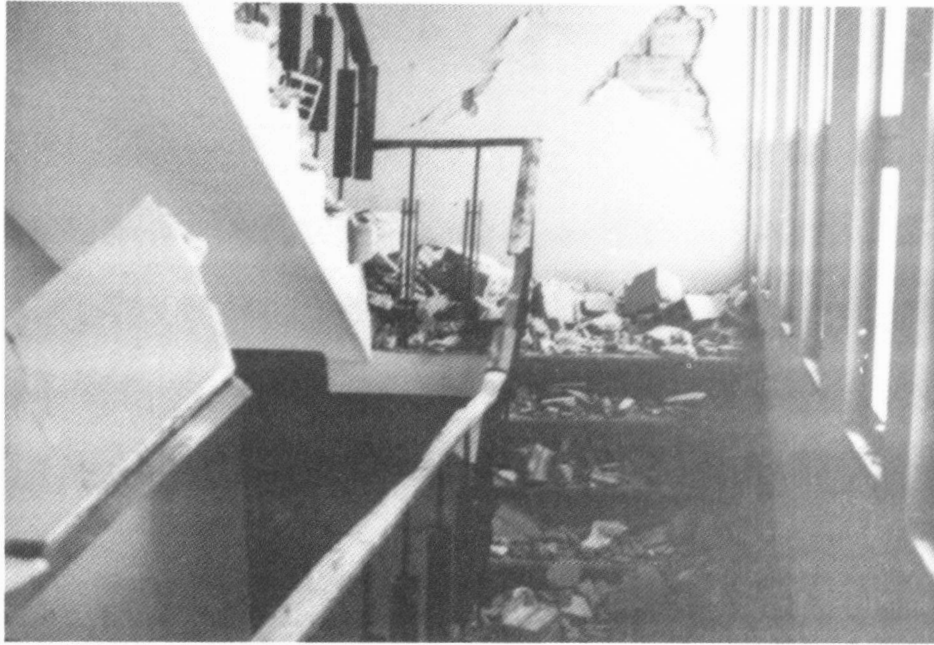
*Stairway blocked by falling wall and ceiling materials.*

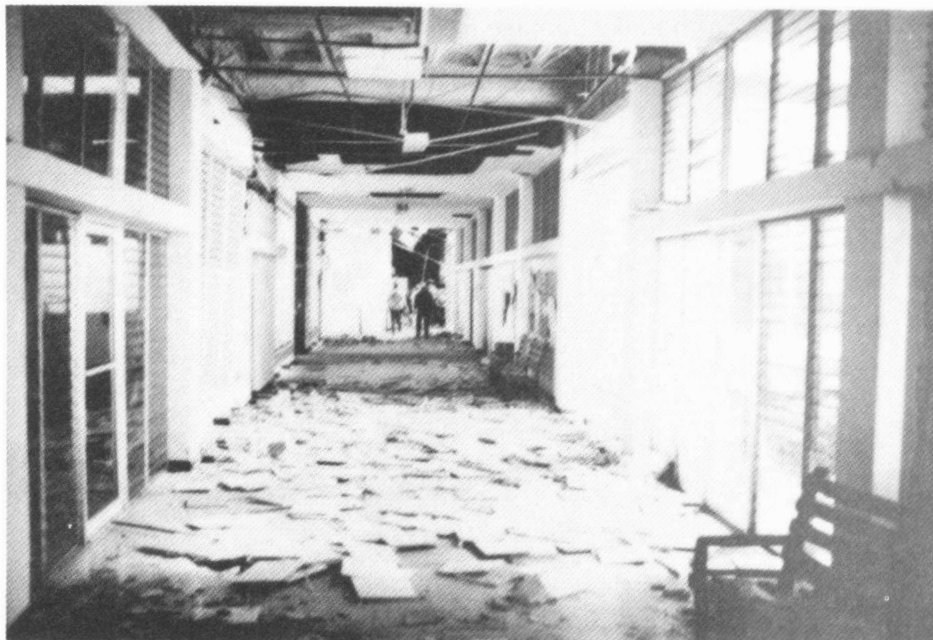
*Hallway blocked by fallen ceiling materials.*

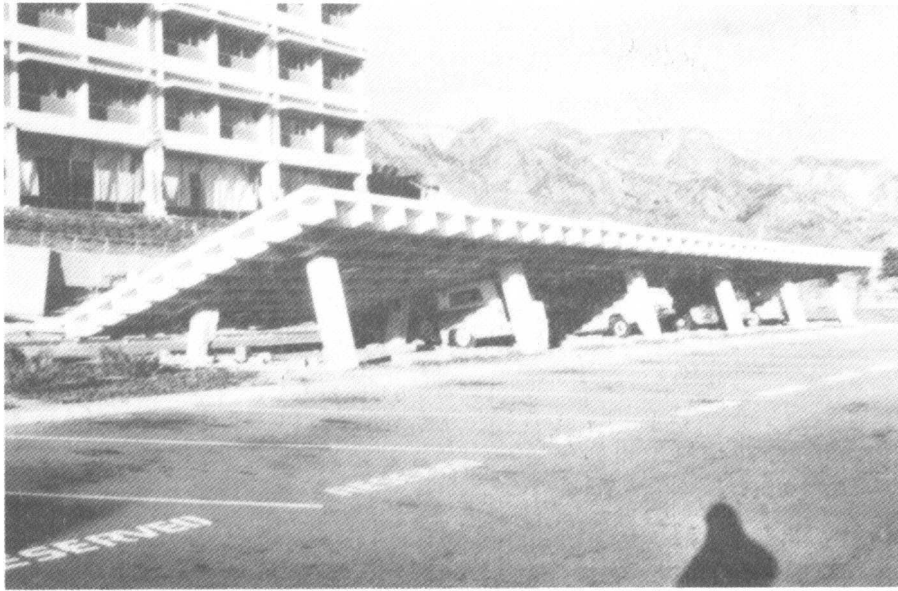
*Parking canopy collapsed on ambulances at Olive View Hospital as a result of the 1971 San Fernando earthquake.*
